Navajo Abandoned Uranium Mine

Site Screen Report

Lloyd House AUM Site

January 2011

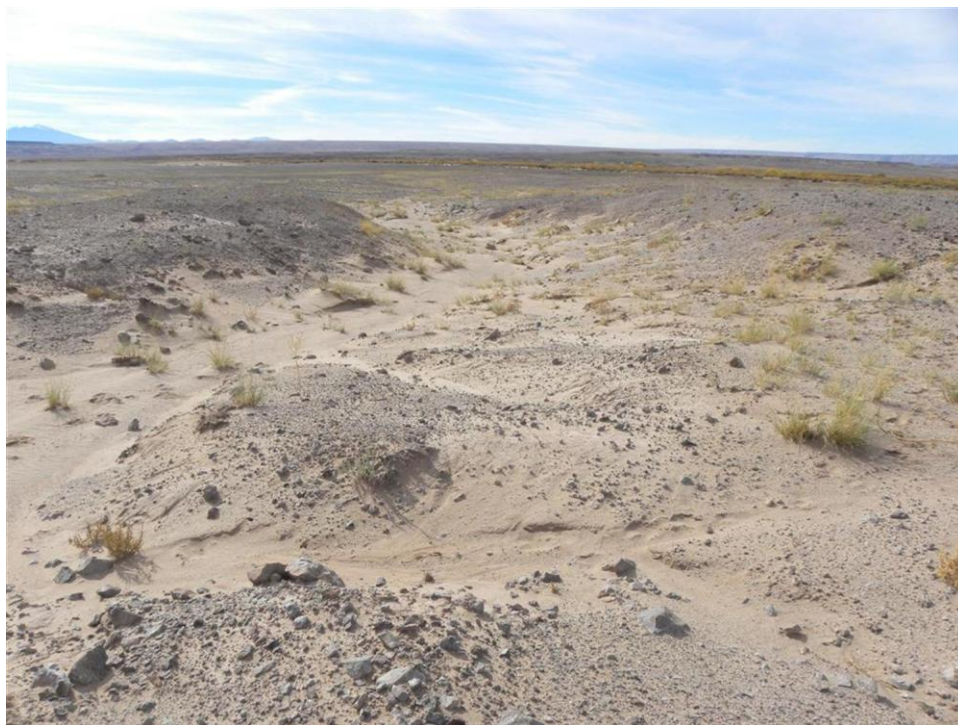
Photo 1. Lloyd House mine site

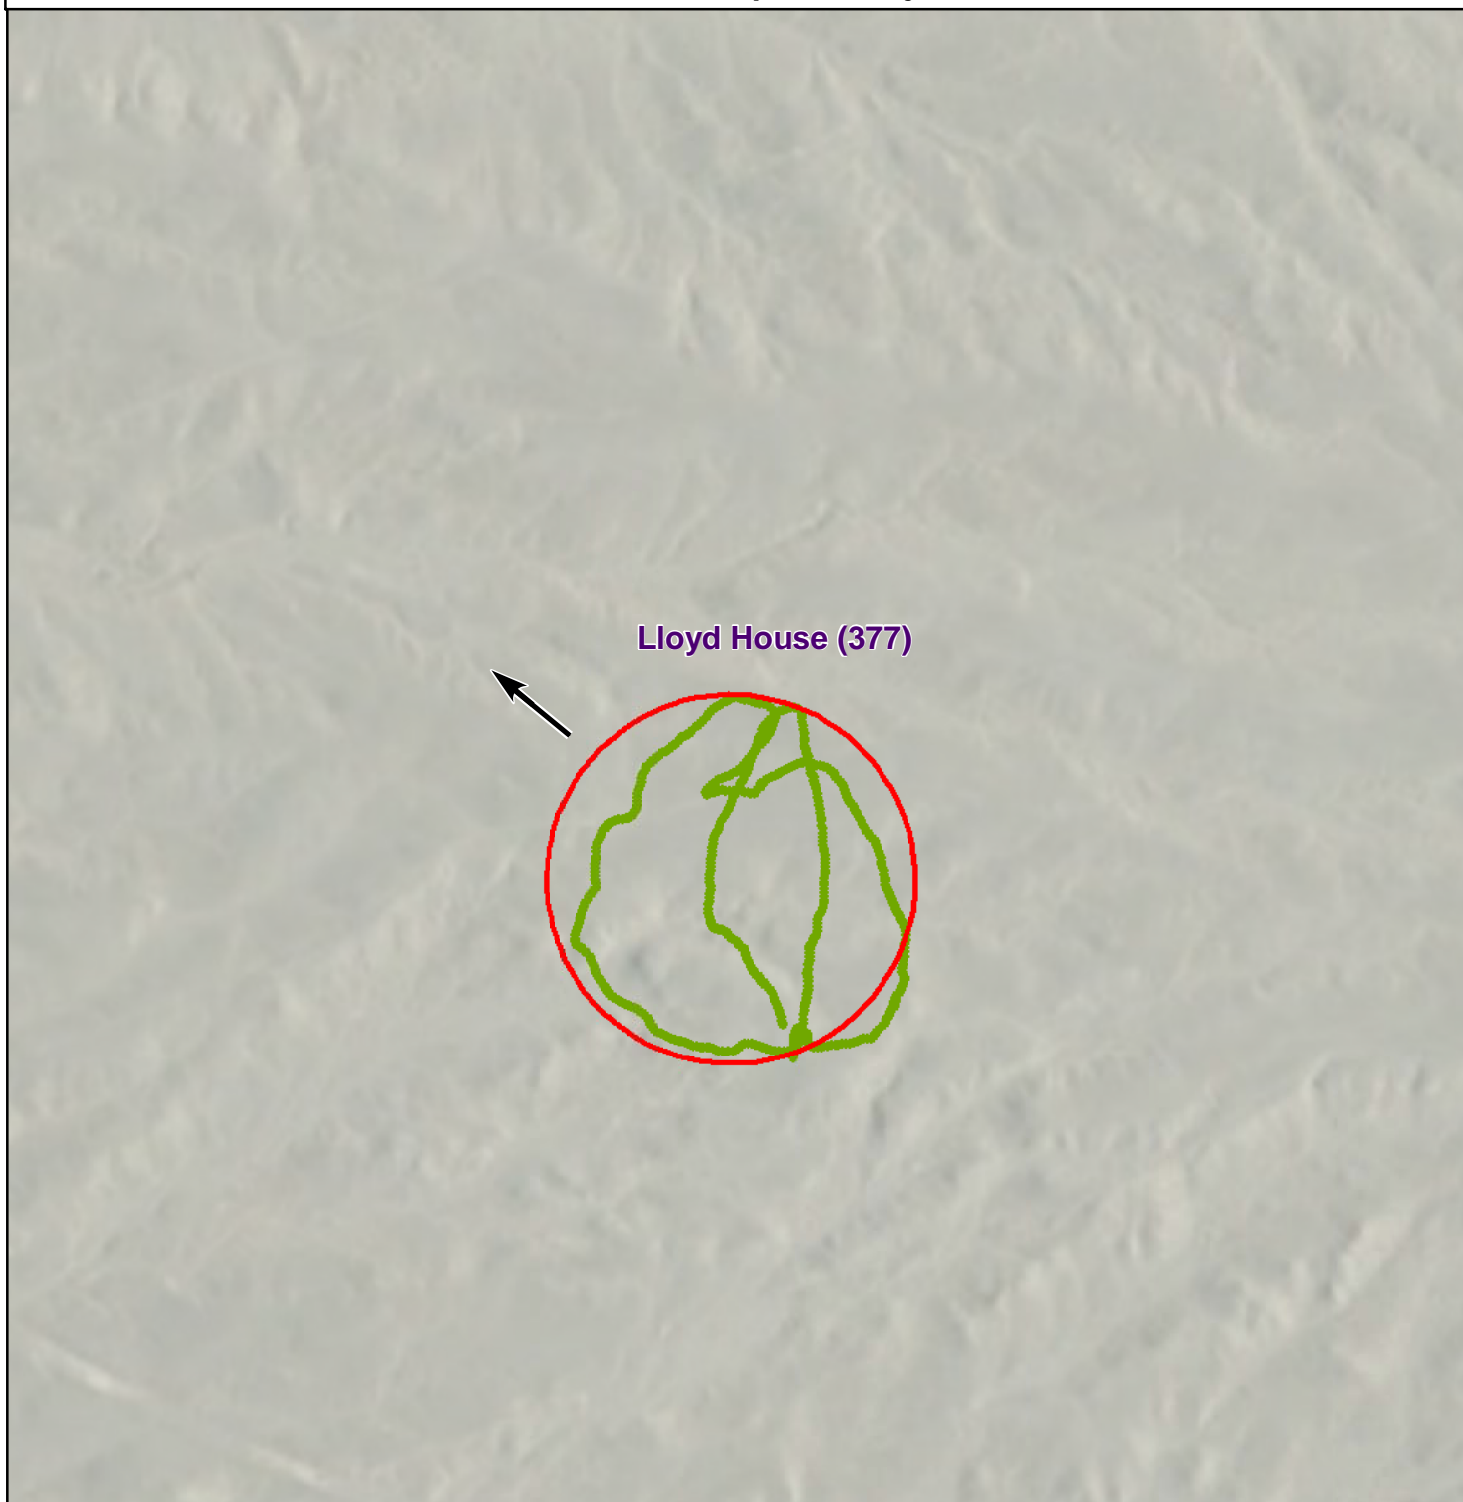
**Figure 1 - Gamma Radiation Measurements, Above Two Times
Lloyd House (377)
Coalmine Mesa Chapter, Navajo Nation**

Gamma survey conducted 11/2010
Measured as counts per minute (cpm)

Average background 9,776 cpm

A total of 623 gamma radiation measurements were collected from the mine site, ranging from 7,875 cpm to 12,801 cpm. The measurements are represented in Figures 1 and 2.
